NASA APOLLO PROGRAM WORKING PAPER NO. 1333

AN INVESTIGATION OF APOLLO TITANIUM PRESSURE VESSEL  
WELDS MADE WITH COMMERCIAL PURE FILLER WIRE

MANNED SPACECRAFT CENTER  
HOUSTON, TEXAS  
January 1968

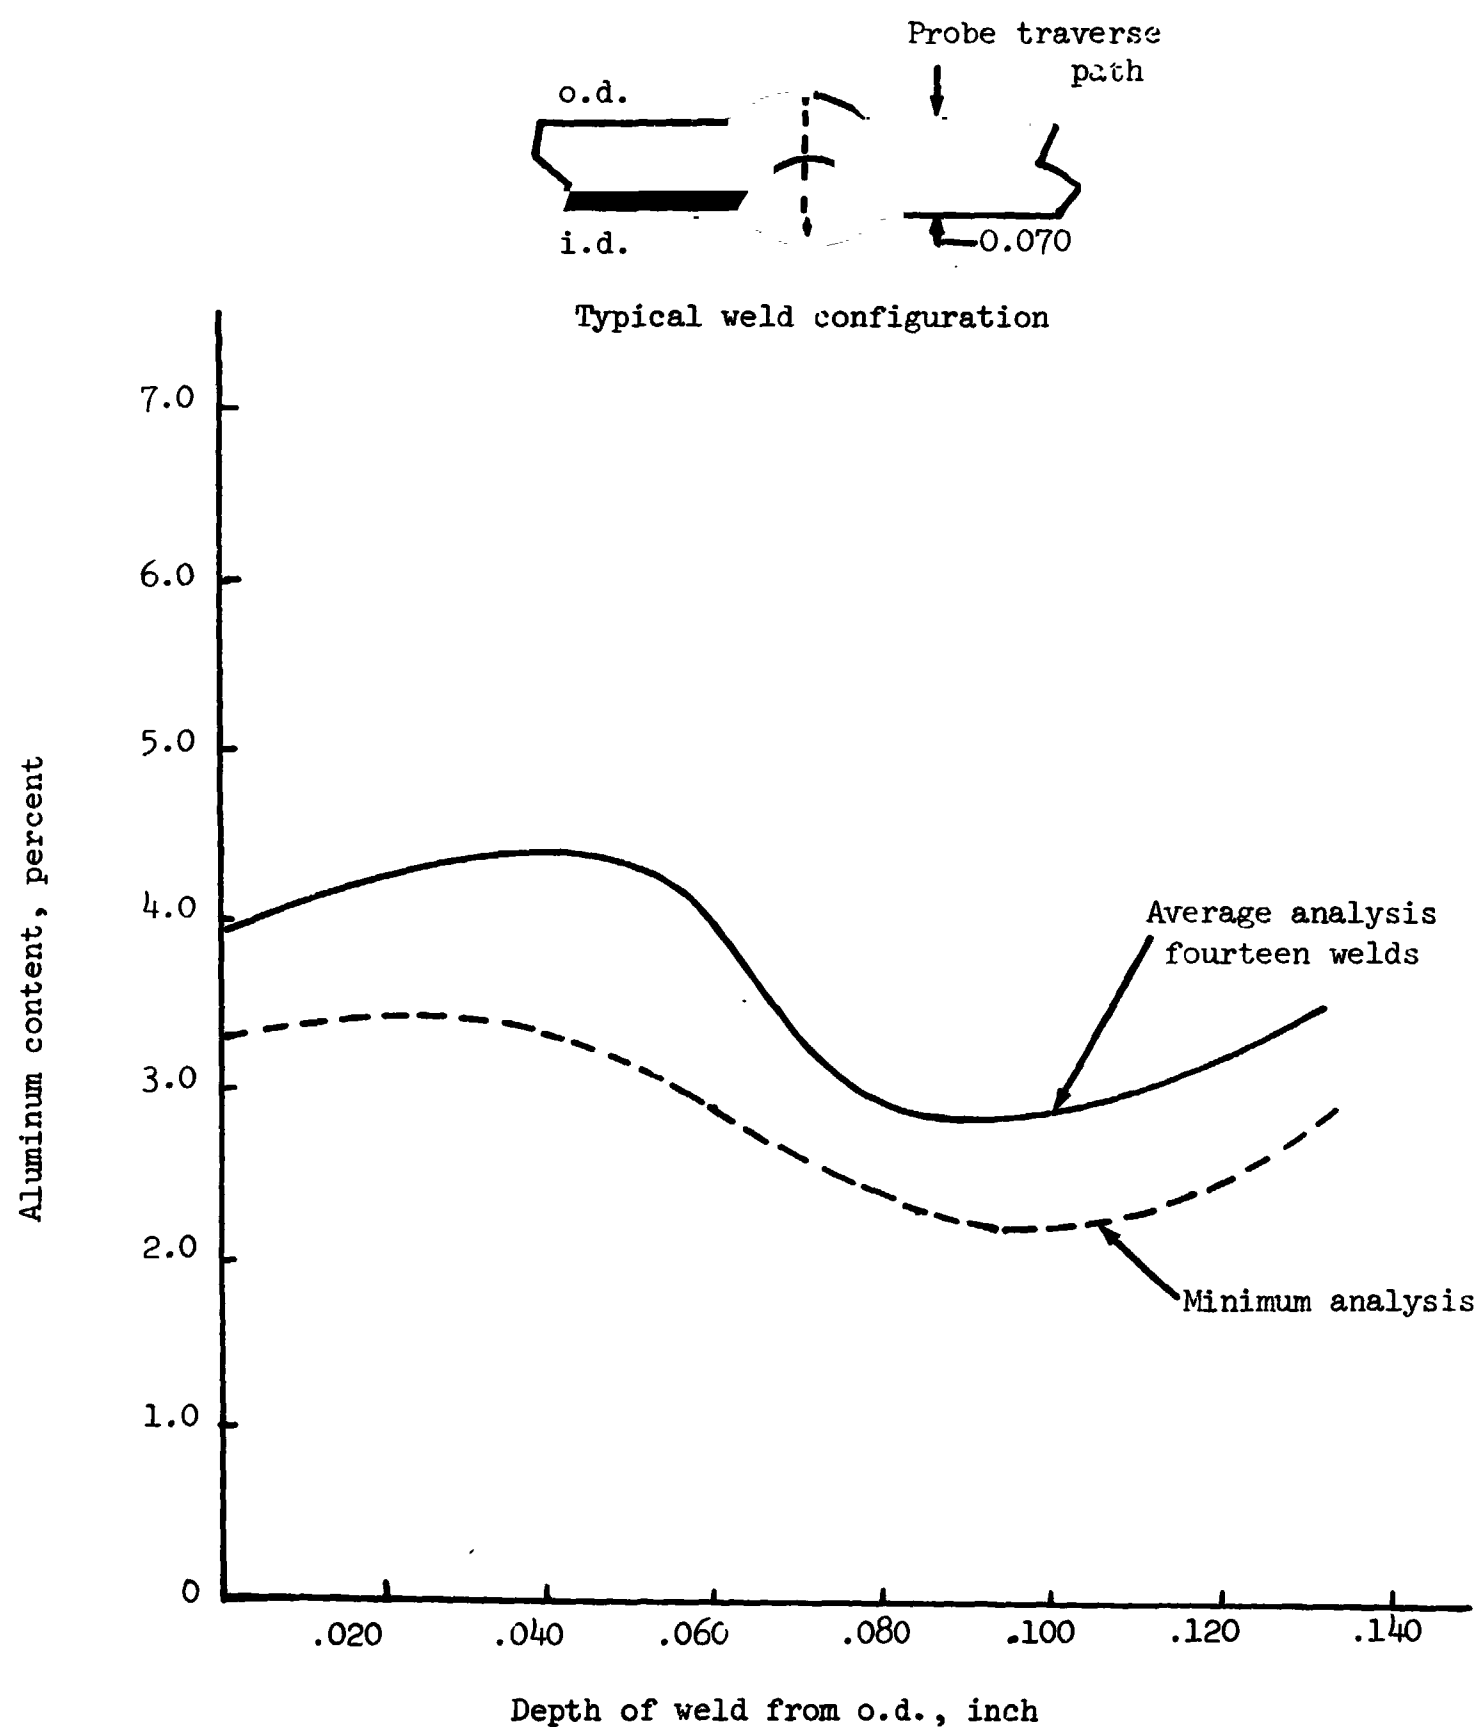
Figure 6.- Aluminum content of Apollo SM/SPS propellant vessel welds.

The average and the minimum analysis for 14 Apollo service propulsion system (SPS) propellant vessel welds are shown graphically in figure 6. It is noted that the analysis for any one of the welds did not go lower than 2 percent aluminum. Based on the 14 analyses, it was decided that 2 percent aluminum could be considered an arbitrary lower limit for aluminum content in Apollo welds. The lower limit was arbitrarily established because anything below this limit would be generally considered as abnormal for the Apollo weld.

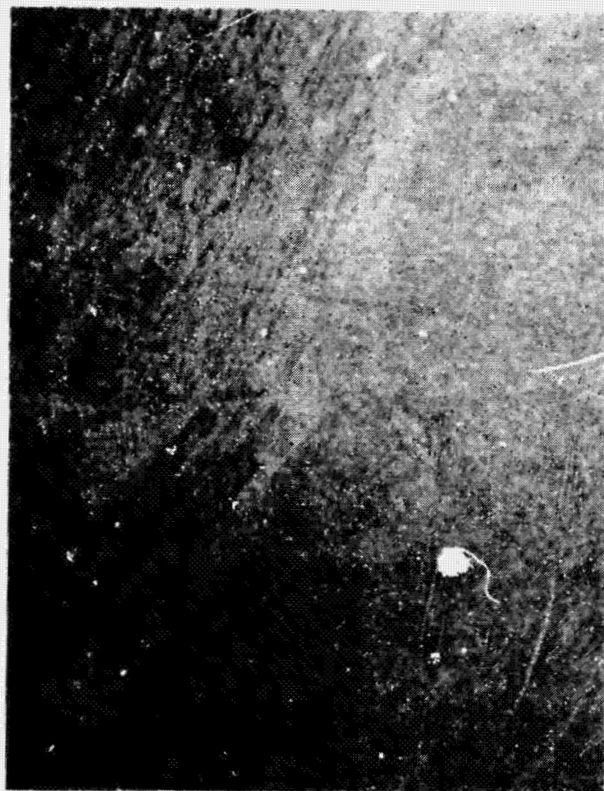
(a) G1 weld (top).

Figure 11.- Photomicrographs of welds from SC 017 fuel tank S/N 023 (X150). Weld metal — parent metal fusion line.

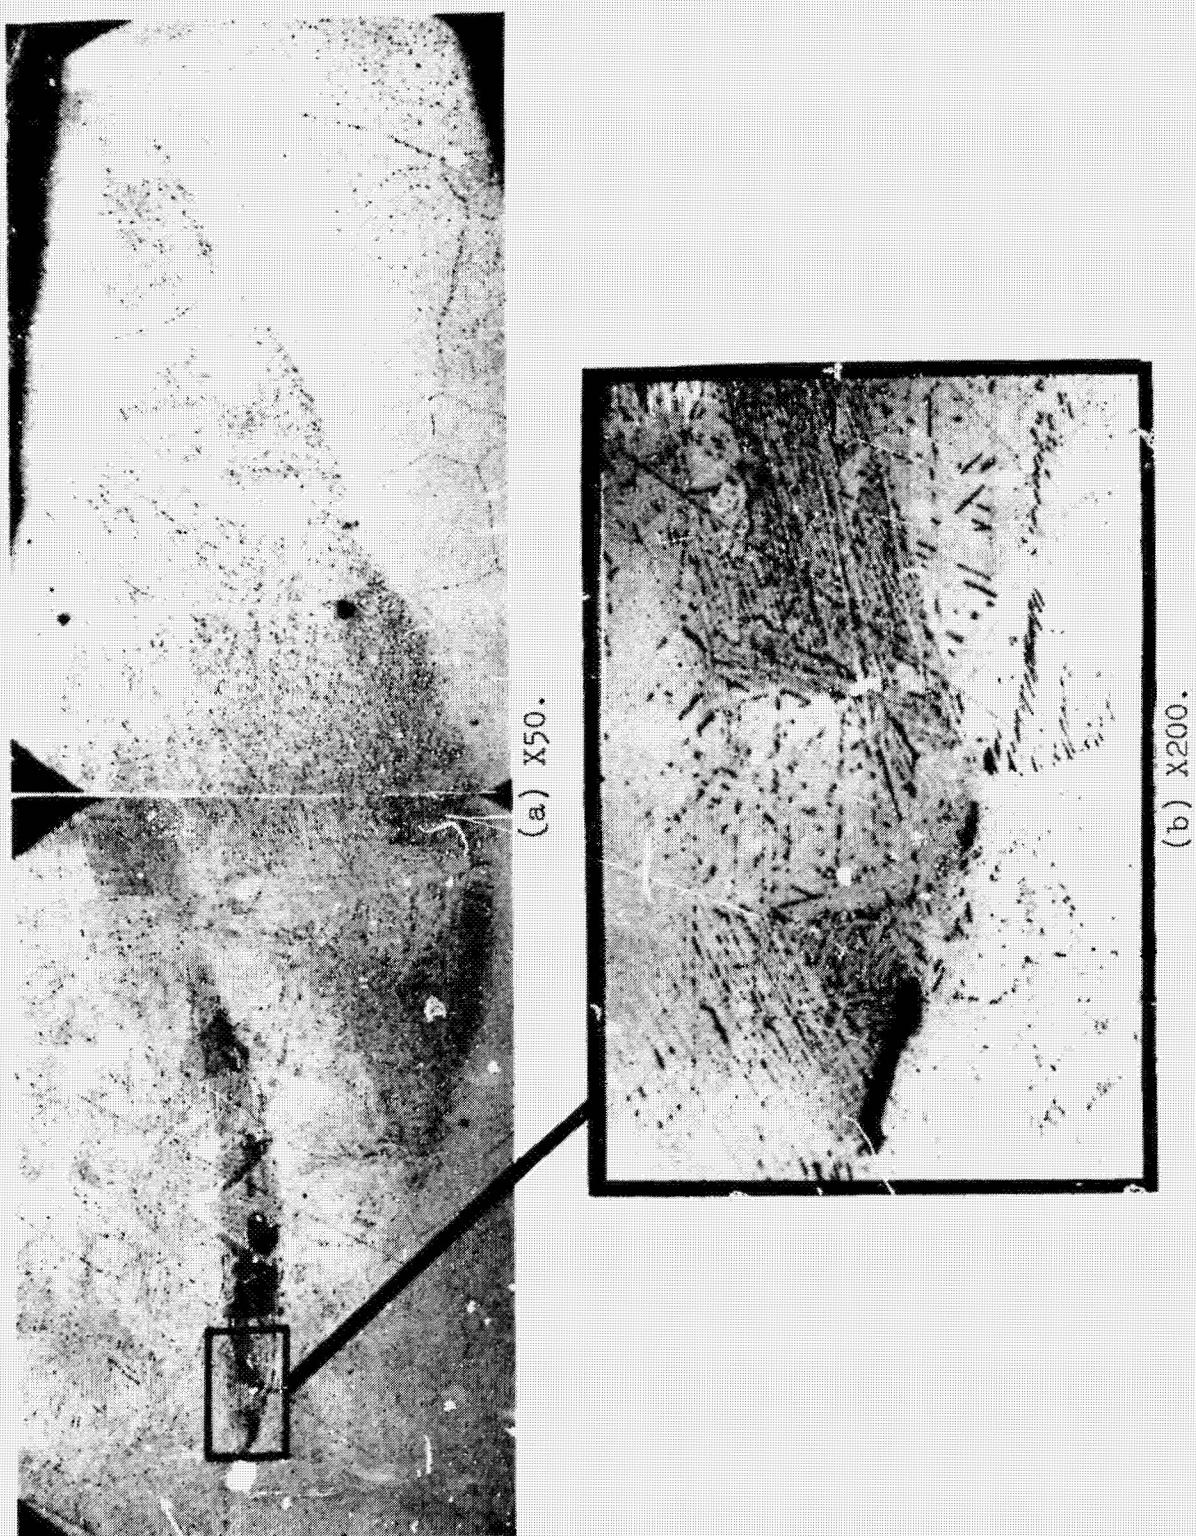
Figure 12.- Photomicrographs of an Apollo double method 2 weld repair, tank S/N 066.

A second significant difference in the welds is noted at the fusion line between weld metal and parent metal. The Saturn weld exhibits a very sharp, distinct fusion line while the Apollo welds do not. The absence of sharpness is indicative of the dissolution and higher alloy content in the Apollo welds. Figures 9, 10, and 11 show the Apollo and Saturn weld structures, respectively. Examination of the "worst case" Apollo weld repair (a double method 2 repair) where the alloy content would be expected to be the lowest, showed no banding or agglomeration of hydrides. One zone in the weld was analyzed to be nearly unalloyed titanium (see fig. 7, S/N 066) and contained a relatively large amount of small scattered titanium hydrides. Figure 12 shows the weld section. An enlargement of the low alloy portion is also shown which exhibits

indications of slight hydride banding and lack of fusion. The condition in no way approaches the severity of hydrides found in the Saturn weld.

It is concluded that Apollo welds made or repaired according to specification requirements are not affected by hydride agglomeration or banding. An exception is a double method 2 repair where the second repair was made off-center to the first. A zone of very low alloy content, less than 1 percent Al, was detected in this repair with evidence of slight hydride agglomeration within this zone. The necessity for a double repair of this type may indicate a serious process problem with the particular weld. For this reason and the fact that the double method 2 repair is a "worst case" repair, considering alloy content, vessels containing such repairs have been removed from use in the Apollo Program. It has been pointed out, however, that an Apollo propellant vessel with two welds repaired by combinations of methods resulting in a low alloy content\* survived an 80-day sustained load test at maximum operating pressure and subsequently was burst above design burst pressure. Examination of the unrepaired and repaired welds from this vessel showed no hydride agglomeration or banding.

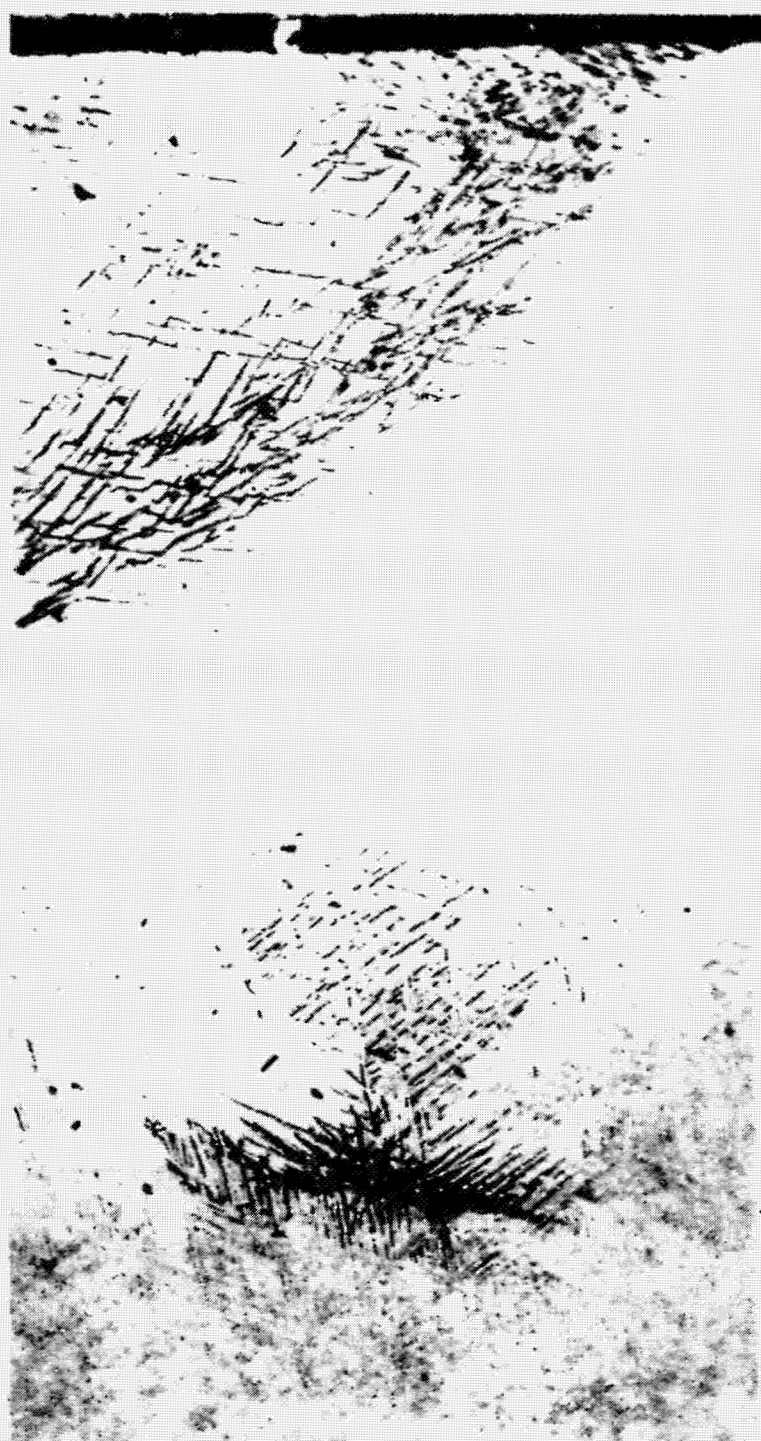
Figure 13.- Photomicrographs showing hydride agglomeration at a fusion line in an Apollo weld (X250).

During the course of this investigation, a problem with CP wire welds was experienced by an Apollo vendor. Metallographic examination revealed hydrides at the fusion zone of a weld repair as shown in figure 13. This condition closely resembles the banding discovered in the Saturn weld. Subsequent investigation disclosed that the affected welds had inadvertently been heat-treated in a hydrogen contaminated atmosphere. The hydrogen introduced externally had selectively precipitated at the fusion line area of the low alloy weld repair. Similar weld repairs not exposed to the hydrogen atmosphere heat-treatment did not exhibit hydride banding. Figure 14 shows the effect on an Apollo weld from introduction of hydrogen by electrochemical action.

NOTE: The weld repair is contaminated by a known hydrogen atmosphere.
